# Precise Detection of Evaporation Boat Breakdown

**Jun-ichi Susaki and Koki Ikarashi**

Denki Kagaku Kogyo K.K. (Nihonbashi-Muromachi 2-1-1, Chuo-ku, Tokyo, 103-8338) Tel:+81-3-5290-5284, E-mail: junichi-susaki@denka.co.jp

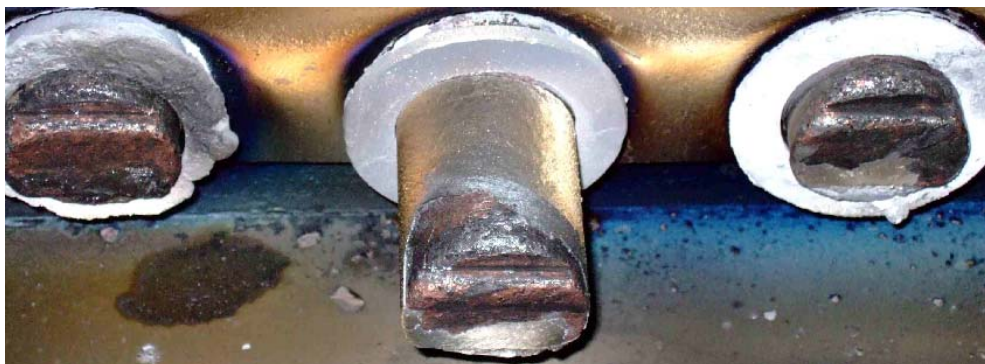
The causes of crack are clamping problem, boat strength, mismatch of boat length and underestimate of the resistivity. These problems are avoidable if an appropriate operation is applied on the optimized boats. Contact between a boat and an electrode is, on the other hand, a serious problem. The electrodes are being damaged after long time evaporation and overflowing aluminum sometimes erodes the surface of electrode (Figure 1). Cleaning electrodes sometimes may waste the surfaces of them worse.

**Fig. 1** Electrodes eroded after long time evaporation

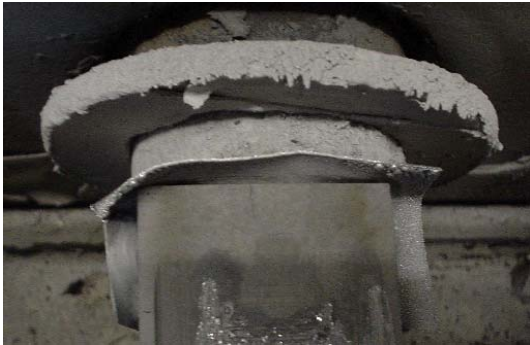
That is why the contact point can play important roll in generating a crack. A small crack is sometimes found at an edge (Figure 2). Some of cracks are possibly grow longer; on the other hand, several cracks may join and collapse the boat edge (Figure 3). The edge of boat is finally chipping or broken down (Figure 4) and the electric current is shut down.

**Fig. 2** Small crack appeared at a boat edge    **Fig. 3** Eroded boat edge by localized heating

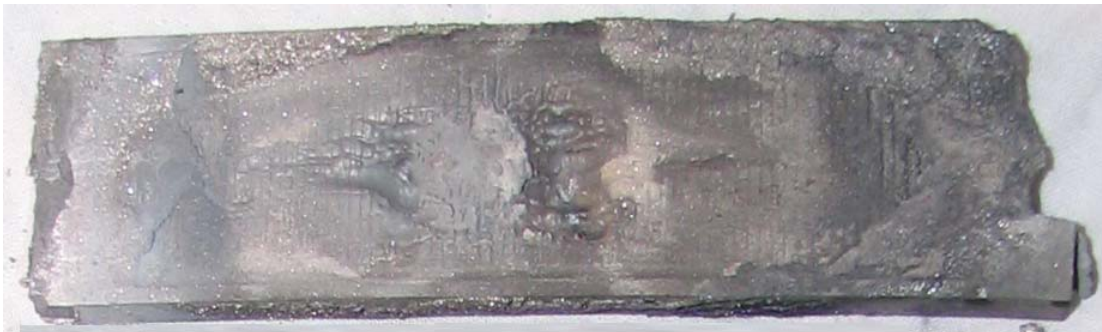
**Fig. 4** Eroded boat edge was finally chipping or broken down

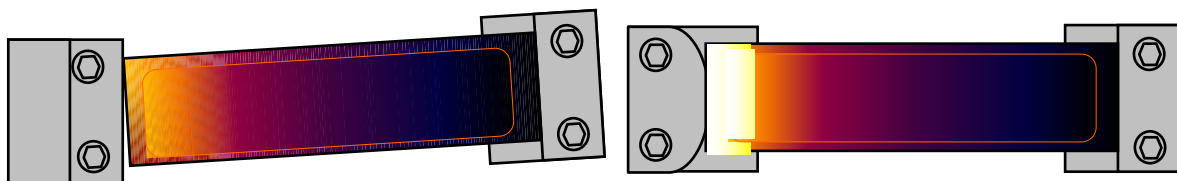
**Fig. 6** Point contact trial with tilted boat (left) and the adopted electrode with curved surface (right).

contact between a boat edge and electrode is not so constant as to obtain the repeatable boat current. Then the electrode was improved with curved surface which guarantees constant contact in any time (right).

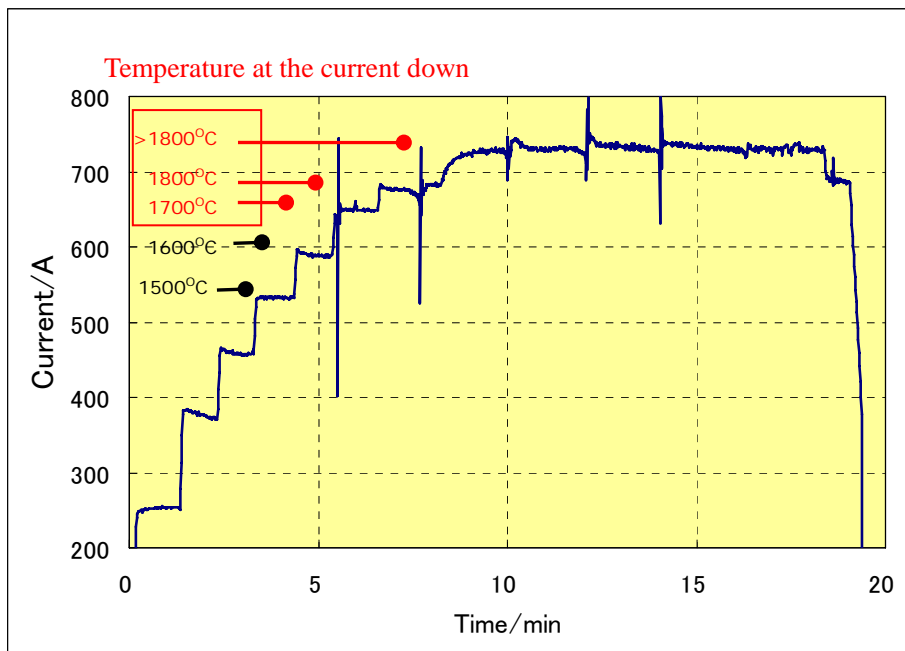
Figure 10 shows an example of boat current down observed for a boat which was destroyed at the edge in the beginning of the evaporation. In this run, the applied power was increased step by step and regulated at each step. The boat temperature is also monitored using an optical meter and added on the graph. When the temperature was increased from 600A to 650A, the first current down about -40% was observed. The consequent current jump was the result of a feedback function of the power source. The similar current down was also observed when the current was around 680A. Then the aluminum wire was fed into the boat and the current was increased further more (Time > 8 min). This current increase also brought rise of the temperature at the boat edge contacted at a point. (Fig.7) Frequent current downs were observed consequently and the boat current was finally shut down. Figure 9 is the edge of the salvaged boat. Discolored area is trace of the overheating caused by the point contact. The block clipping, which brought the current shut down, is observed. Microscopic observation revealed small cracking at 5mm depth from the edge surface. Frequent current downs were caused by generation and growth of cracks which can prevent the boat current.

**Fig. 7** Boat current in increasing temperature and observed current downs of a boat which was destroyed at the edge.

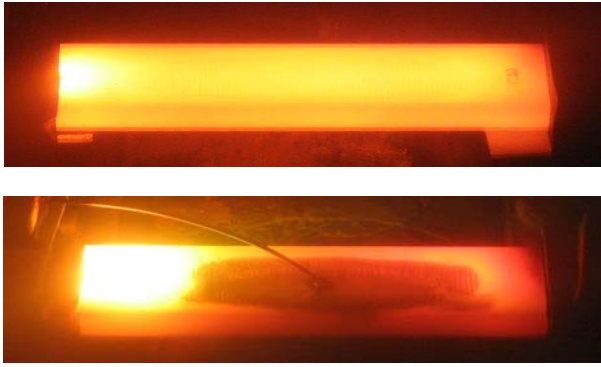
**Fig.8** Thermal concentration at the point contact of electrode. Above: Before evaporation, Below: During evaporation.

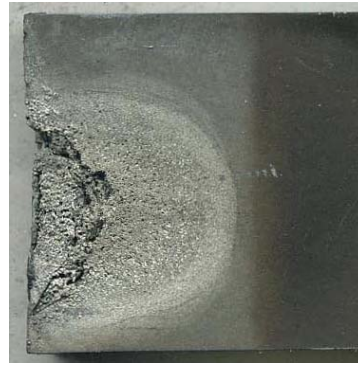
**Fig. 9** Damaged and clipped edge of the boat applied in the measurement of Fig10.

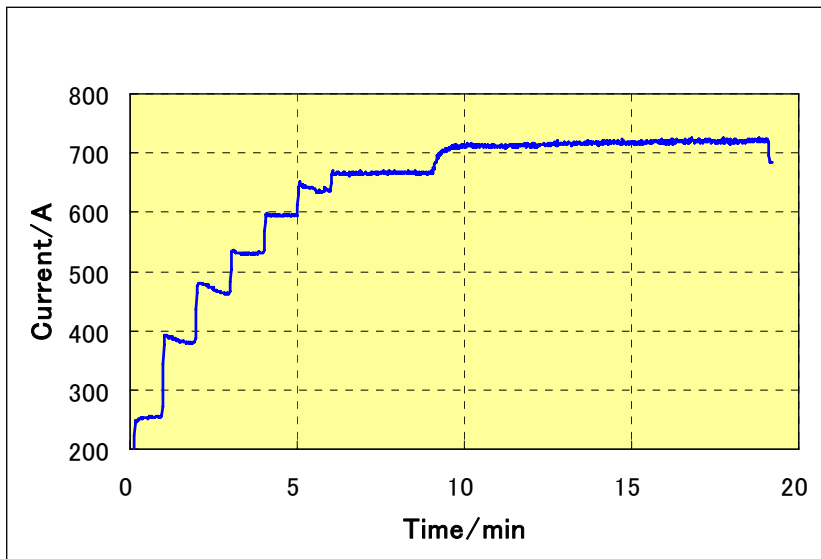
The purpose of in-situ crack observation is actually to evaluate anti-crack boats developed. Figure 10 shows typical data and figure of the boat. This boat is an 'edge intensified boat' of which the edge is improved to reduce the thermal stress. No current down is observed at every step up of the applied power and the aluminum evaporation is started without any problem. Attached figure shows little damage at the boat edge.

**Fig.10** Boat current profile in increasing temperature of the edge intensified boat. Figure (right) shows damage at the edge is not severe in spite of the discoloration by overheat.

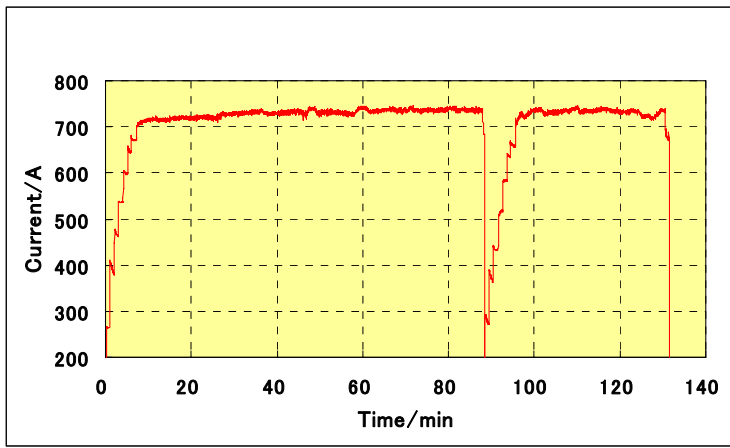
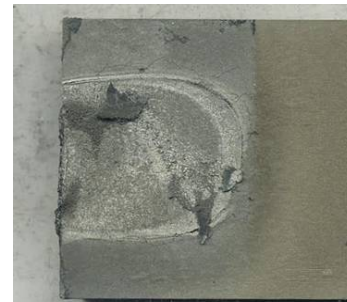
Even if the evaporation is started without current down, new crack is possibly generated and growing during aluminum evaporation. Those cracks accumulate damages at the edge and edge block is sometimes clipped off in the middle of the evaporation. In the next step, the boat current monitor was continued during two hours approximately. Short time shut down was inevitable during the test to exchange the aluminum wire roll. Figure 11 shows the acquired data on the 'edge intensified boat'. Any remarkable current down was not observed during the evaporation. The photograph reveals damage at the boat edge was not so serious as to make boat current unstable.

**Fig.11** Boat current profile throughout the evaporation up to two hours. Data were acquired on the 'edge intensified boat'.

Figure (right) shows damage at the boat edge was not so serious

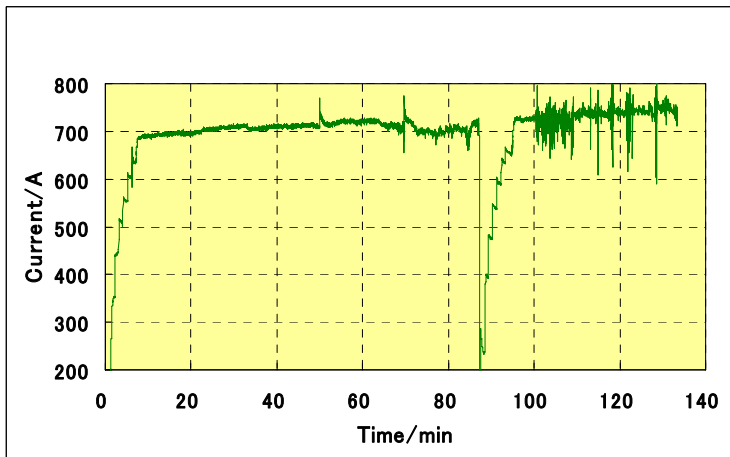
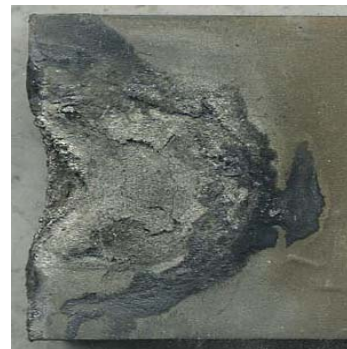
**Fig.12** Boat current profile throughout the evaporation up to two hours. Data were acquired on a boat of other brands.

Figure (right) shows a clip of damaged block.

Figure 12 shows data acquired on a boat of other brands. Several current downs were, on the contrary, observed before the aluminum wire roll change. The current was changed to be unstable after the aluminum wire roll change and finally shut down after frequent current downs. The figure of the boat edge showed a clip of damaged block.
