CHEMICAL ANALYSIS OF THE POLYESTER/METAL SURFACE OF A DELAMINATION FAILURE

Eldridge M. Mount III EMMOUNT Technologies Fairport, NY, 14450 United States

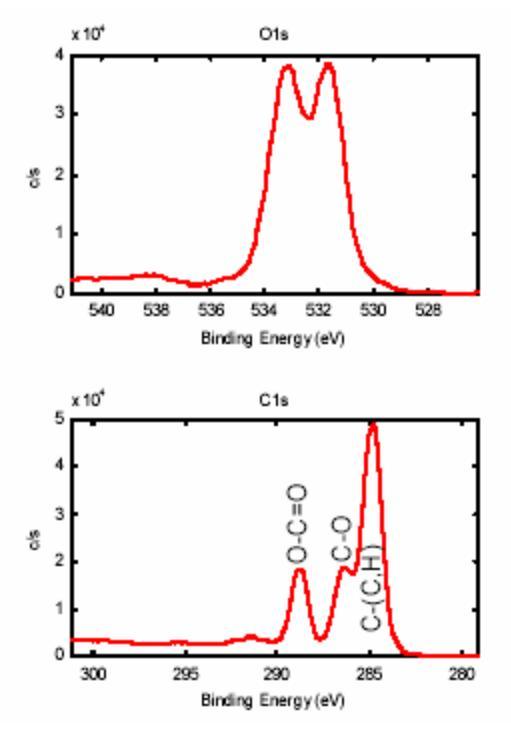
Figures 4a ,4b, 5,a, 5b, 6a & 6b show the high resolution XPS oxygen and carbon 1S spectra for the exposed PET surfaces of samples 1, 2 & 3 respectively. It is clear from these figures that the PET surface of samples 2 & 3 has been chemically changed form the native PET polymer surface.

Figure 4a & 4bb, O1s and C1s spectra of exposed PET from sample #1 showing spectra typical of PET polymer surfaces

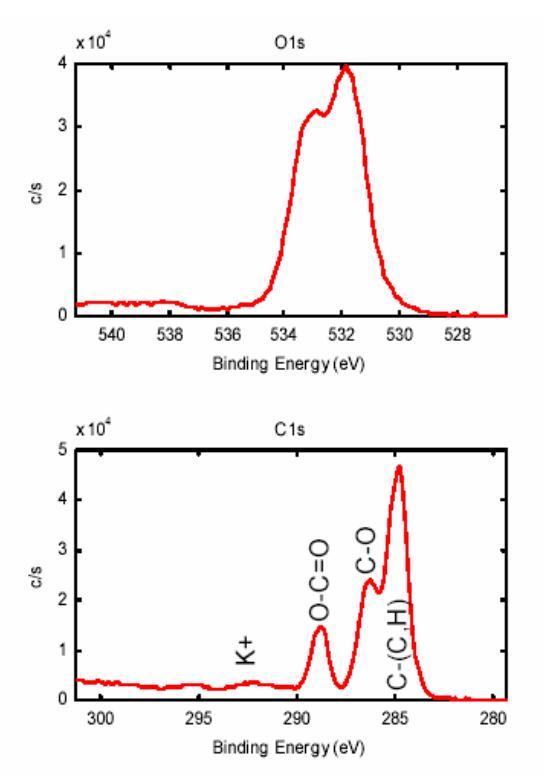
It is clear from the XPS analysis of the good (sample 1) and bad (samples 2 & 3) laminations that the metallized PET surface of samples 2 & 3 have been chemically modified in some fashion which is increasing the concentration of C-O species at the film surface. This is perhaps indicative of an increase in acid O=C-OH and/or glycol C-OH end groups on the PET surface. This would imply that the PET surface has been reduced in molecular weight or that it contains an increase in reduced molecular weight PET which would be consistent with the presence of a weak boundary layer at the PET film/metal interface giving rise to the decreased bond strength and the increased metal lift in laminations 2 & 3. This chemical change of the PET surface was not seen in sample 1 which exhibited acceptable lamination bond strength.

Figure 5a & 5b:O1s and C1s spectra of exposed PET from sample #2 spectra showing excess C-O relative to typical of PET polymer surfaces

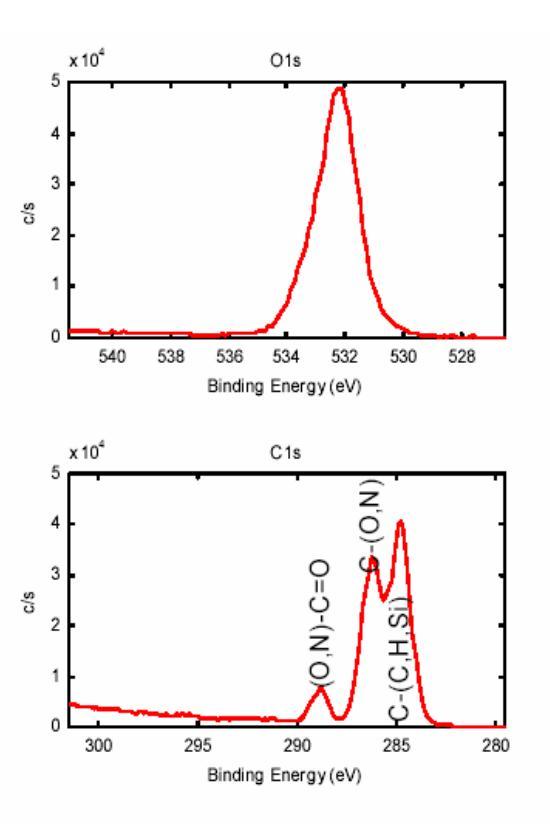
Figure 6a & 6b: O1s and C1s spectra of exposed PET from sample #3 spectra showing excess C-O relative to typical of PET polymer surfaces

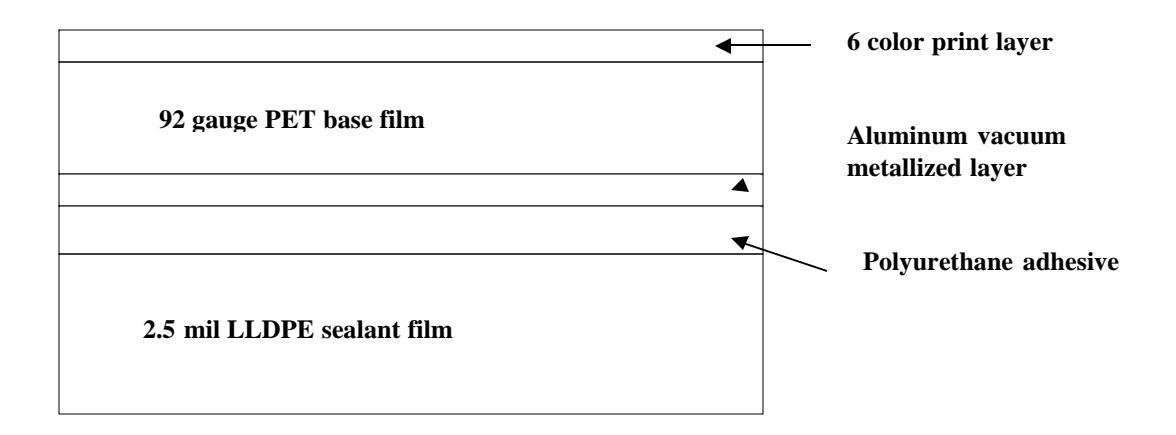
Figure 1: Schematic diagram of the sealable printed, metallized adhesive lamination showing the delamination at the PET/Aluminum interface
