CHEMICAL ANALYSIS OF THE POLYESTER/METAL SURFACE OF A DELAMINATION FAILURE

Eldridge M. Mount III EMMOUNT Technologies Fairport, NY, 14450 United States

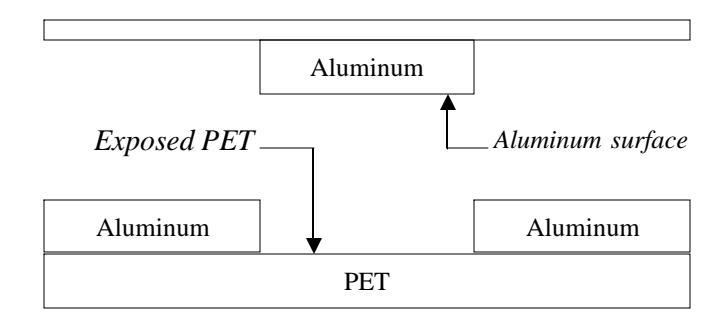
Figure 2: Schematic diagram of delaminated lamination and locations of the XPS surface analysis.

The XPS samples were prepared from the retained samples with an initiated delamination of the metal/film interface and were supplied to Evans East in East Windsor NJ, where they were further prepared for XPS analysis. This was accomplished by exposing previously unpeeled mating layers which were peeled revealing "fresh" areas of adhesion failure (Figure 2). Both sides of the failure were examined initially by low-resolution XPS survey scans to determine which elements were present. High-resolution XPS spectra were acquired to determine the binding energy (i.e., chemical state) and concentration of the elements observed in the survey spectra. The quantification of the elements was accomplished by using the atomic sensitivity factors for a Physical Electronics Model 5700LSci ESCA spectrometer. The approximate escape depth ($3\lambda \sin\theta$) of the carbon electrons was 80Å. Table 1 lists the atomic concentrations measured for samples 1, 2 and 3 on both the exposed aluminum surface and the exposed PET surface in the exposed regions of the delamination.

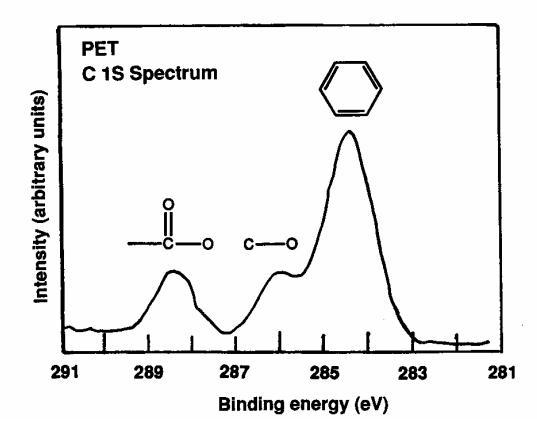
Figure 3a: Oxygen 1S spectrum for PET

Figure 3a and 3b shows the typical high resolution oxygen and carbon 1S spectra for a PET polymer surface. In figure 3a we note the symmetrical peaks for the C-O and C=O 1S spectra due to the equal number of C-O and C=O functional groups in the PET molecule.
