# Precise Detection of Evaporation Boat Breakdown

**Jun-ichi Susaki and Koki Ikarashi**

Denki Kagaku Kogyo K.K. (Nihonbashi-Muromachi 2-1-1, Chuo-ku, Tokyo, 103-8338) Tel:+81-3-5290-5284, E-mail: junichi-susaki@denka.co.jp

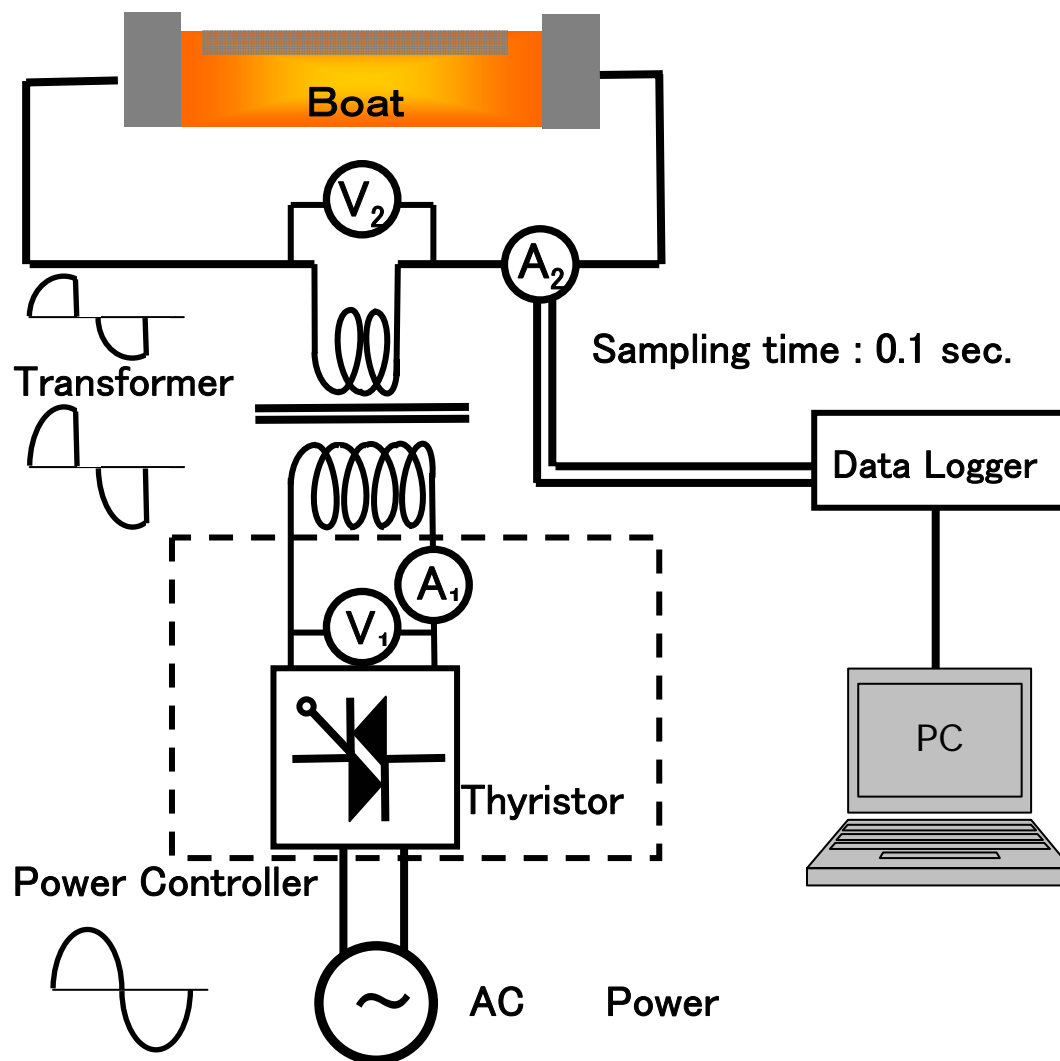
**Fig. 5** Block diagram of a boat heater power circuit and data acquisition system of boat current. Current from commercial AC input is controlled by an electric device and transformed in advance of the boat circuit. The boat current is monitored directly.
